SOLAR TURBINES INTERNATIONAL SAN DIEGO CA
APPLICATION OF CERAMIC NOZZLES TO 10 KW ENGINE. (U)
DEC 78 J C NAPIER, A G METCALFE, T E DUFFY
SR80-R-4375-43

12
Final Report
S.O.-6-4375-7

Application of Ceramic Nozzles to 10 kW Engine

Prepared for
U.S. Army Mobility Equipment
Research and Development Command
Electrical Power Laboratory - DRDME-EMA
Fort Belvoir, Virginia 22060

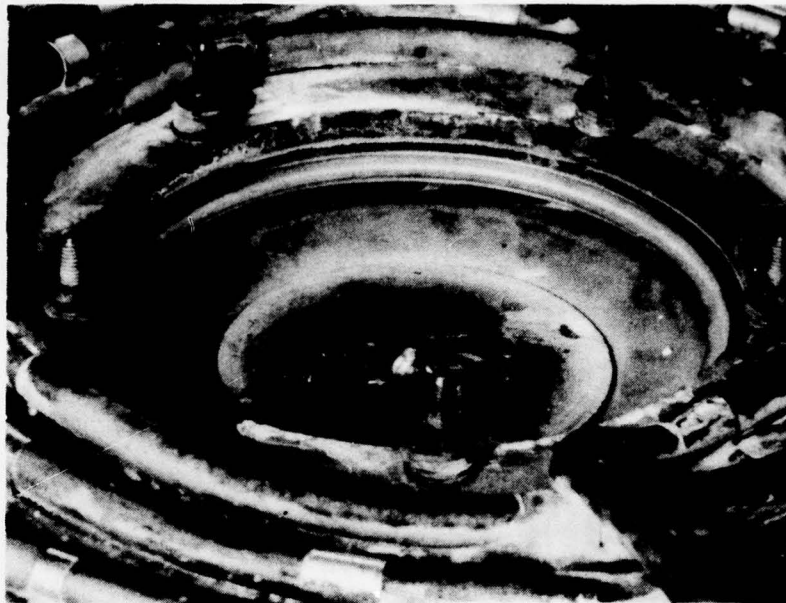
Figure 35. Cooled Nozzle Test Chamber With Ceramic Vane Nozzle Installed

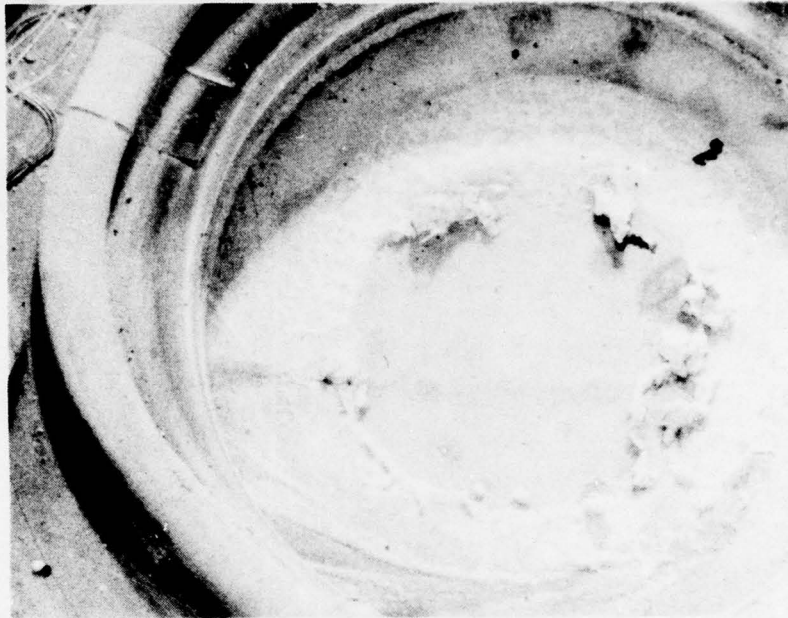
Figure 72a. View of Crack From Downstream Side of Ceramic Nozzle

A crack developed at locating pin 'B' during test and propagated towards the center of the upstream shroud. It is shown in Figures 72 and 73. Other cracks occurred at locating pin 'A' (see Fig. 74) but did not propagate beyond the pin region. It appears that the cracks resulted from localized thermal stresses since the pins run relatively cool because of direct mounting to the water cooled stainless steel plate. The refrasil insulation wafers between the holding pin head and lower shroud were found to be impregnated with molten products at locations 'A' and 'B'. The insulating wafer at location 'C' was relatively free of molten materials. Since location 'C' on the lower shroud showed no cracking it seems probable that the short circuiting of the thermal insulation at location 'A' and 'B' was the primary cause of high thermal stresses and shroud cracking. The appearance of the crack (shown in Figure 75) as it follows the circumference of the pin head strongly supports this conclusion.

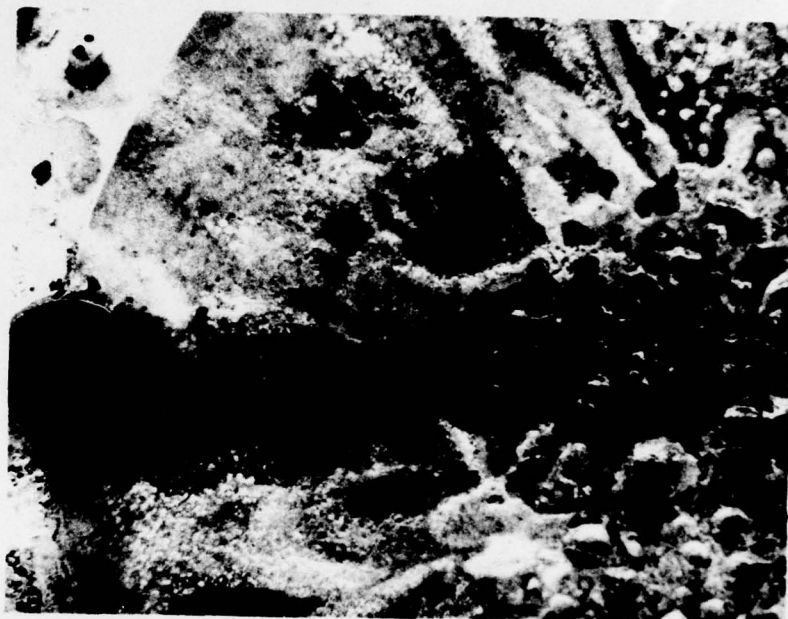
Figure 73. Crack Originating at Holding Pin 'B' (Dye Penetrant Applied for Visibility in this View)

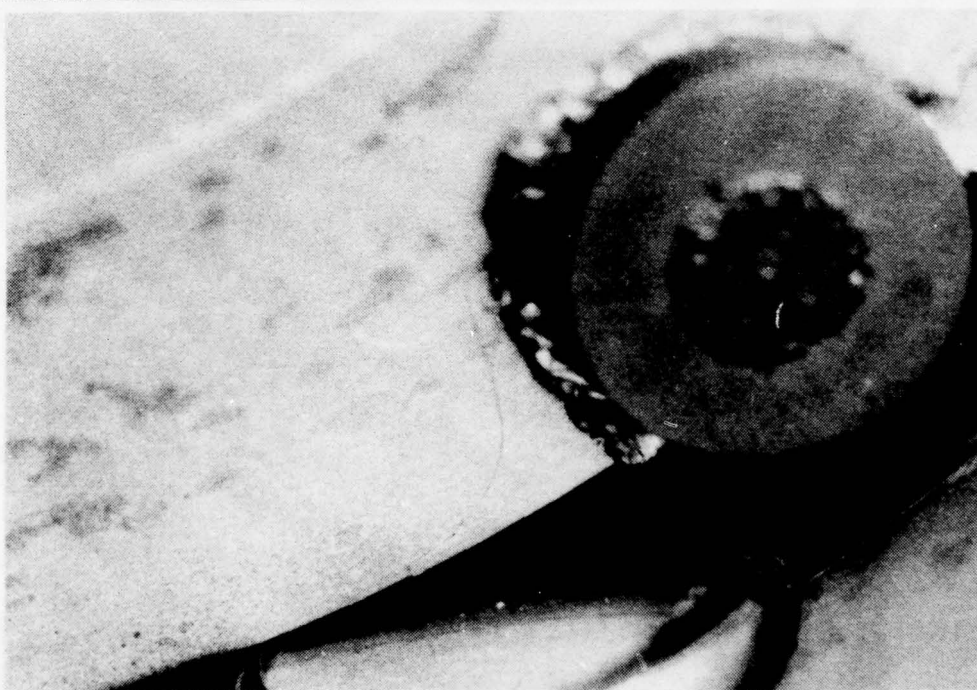
Figure 188. Crack in RBS13N4 Rear Shroud After 33 Hours Engine Running
